SUBJECT: Data Release for PCB Aroclor Results from the Region 10 USEPA Laboratory

PROJECT NAME: Rainier Commons

**QUALITY ASSURANCE MEMORANDUM
FOR ORGANIC CHEMICAL ANALYSES**

Subject: Quality Assurance Review for Rainier Commons
Project Code: OOO-142A
Account Code: 0910B10P201B53C

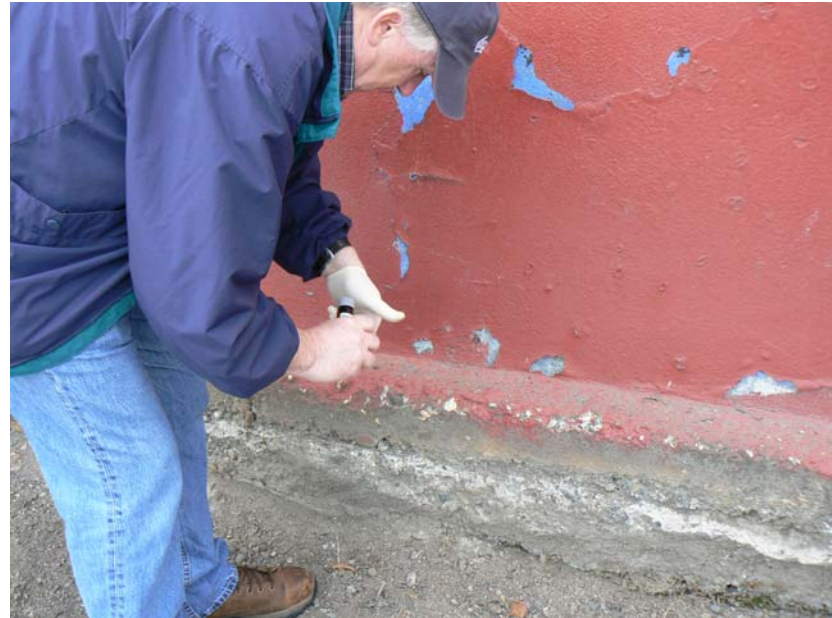
Description: West wall of Building 13. This is the location of Sample 09354100. This sample was collected approximately 30 feet south of the sample collected by EPA in March 2009

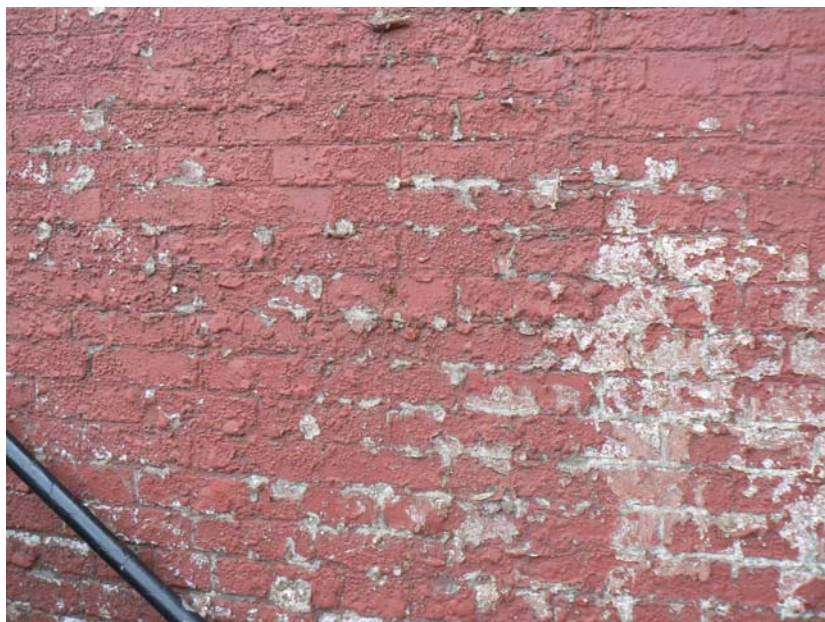
Photo No: P101129

Description: Flaking red paint on the lower section of the smokestack.

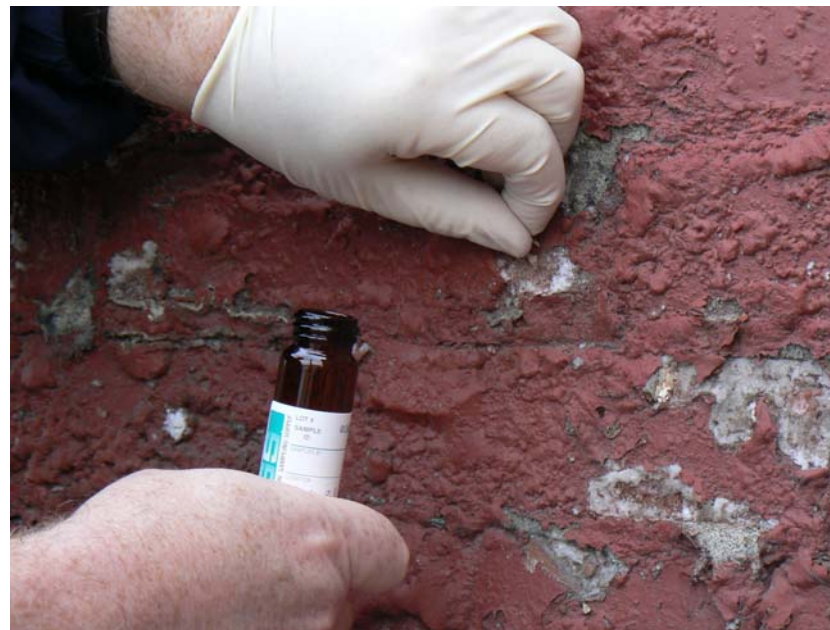
Description: Sample 09354101 was collected from the lower section of the smokestack. This sample is approximately 12 feet above street level.

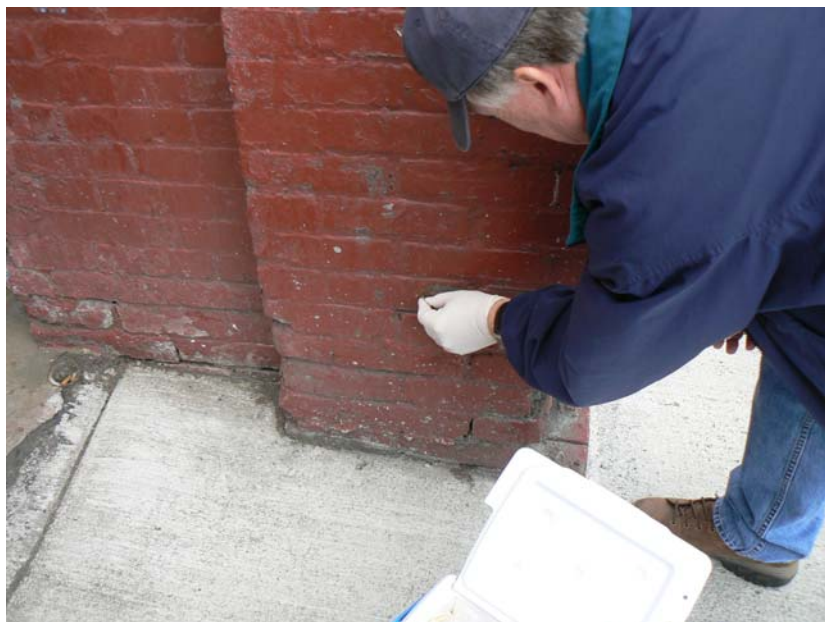
Photo No: P101131

Description: Northwest corner of Building 12. This is the location of sample 09354102. To the left is the doorway into the PCB storage for disposal unit.

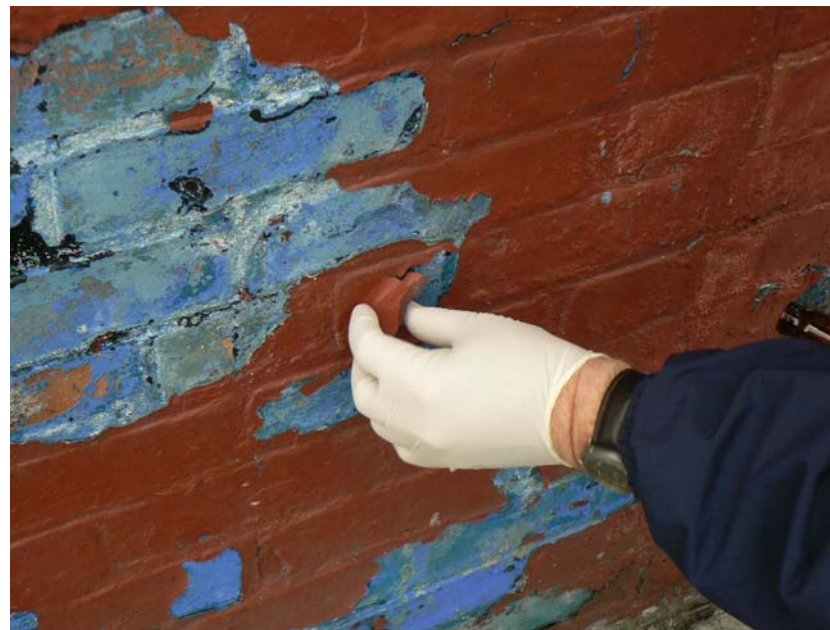
Description: : Northwest corner of Building 12. This is the location of sample 09354102.

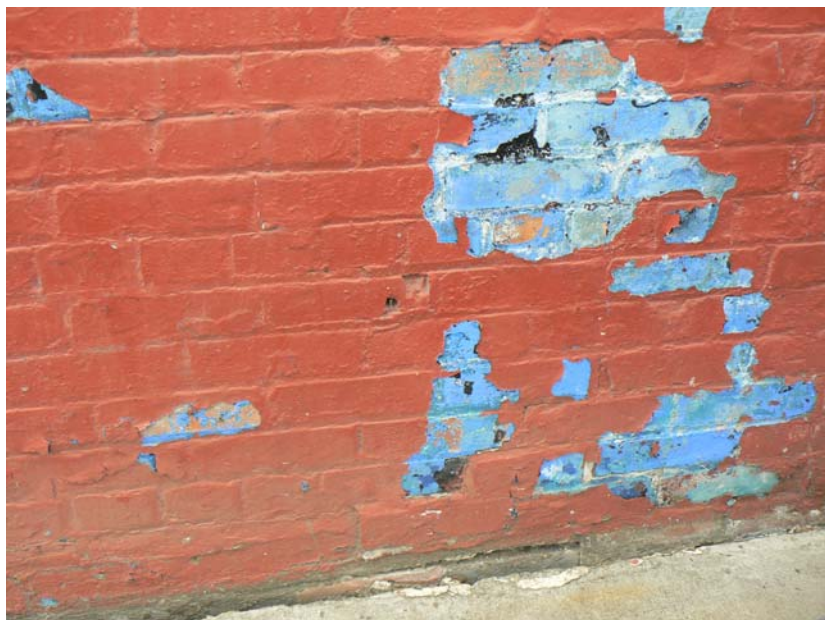
Photo No: P101135

Description: Location of sample 093541003. The paint colors under the outer coat of red vary from black to blue. The black paint is below the blue paint seen in the photograph.

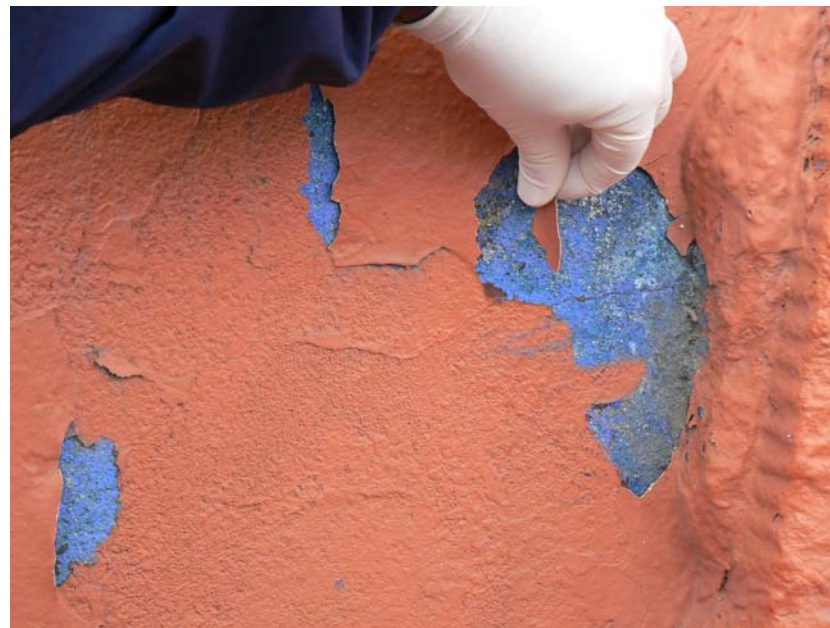
Description: Location of sample 09354104. The under coats of paint range from orange, beige to blue.

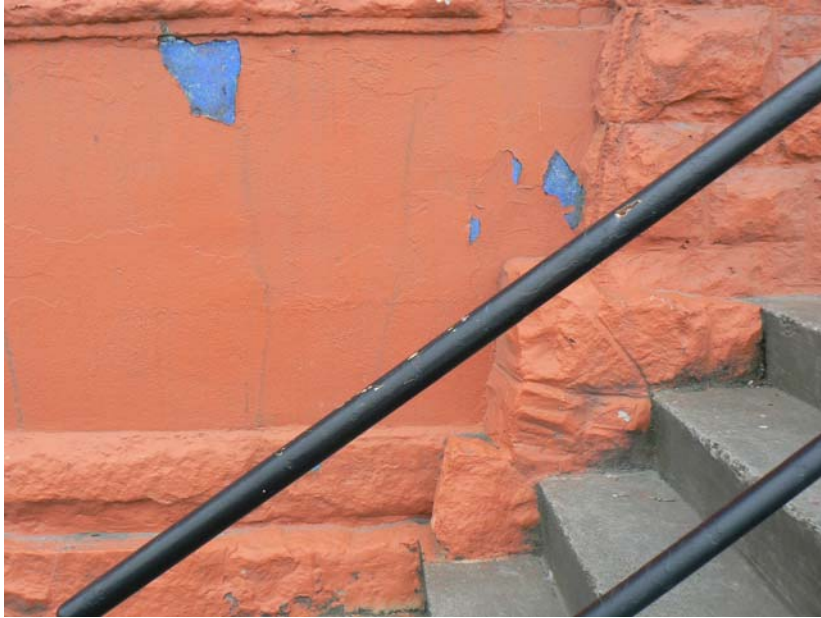
Photo No: P101137

Description: Additional view of location of sample 09354104

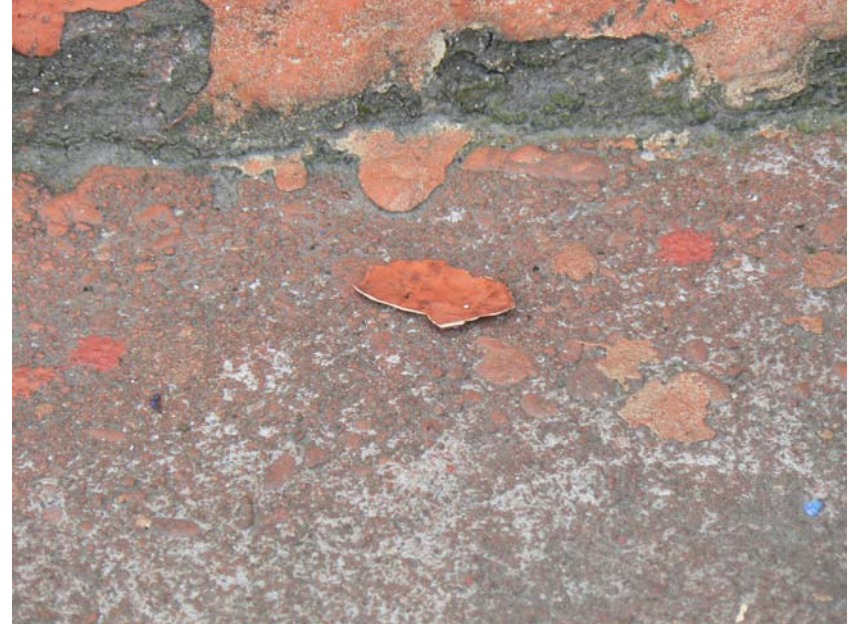
Description: A fallen paint chip about the size of a US Quarter.

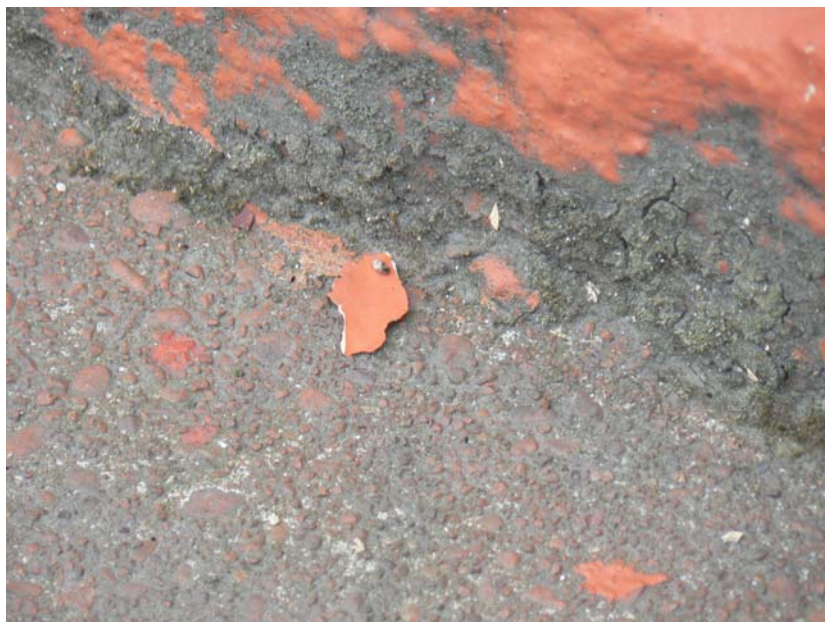
Photo No: P101139

Description: An additional fallen paint chip about the size of a US Quarter.

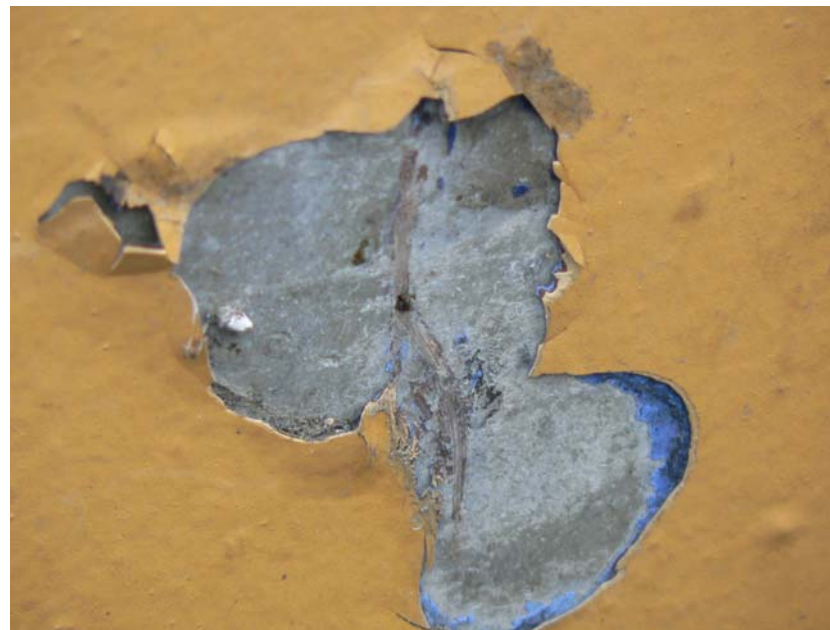
Description: Location of sample 09354105. The under coats of paint is a metal metallic in color. The concert wall is exposed here.

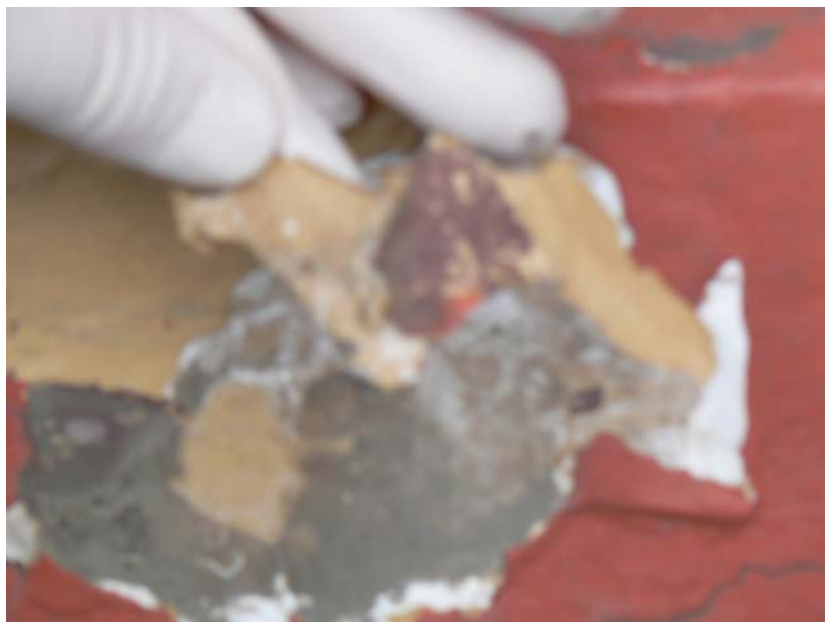
Photo No: P101141

Description: Showing the older coats of paint on Building 5A.

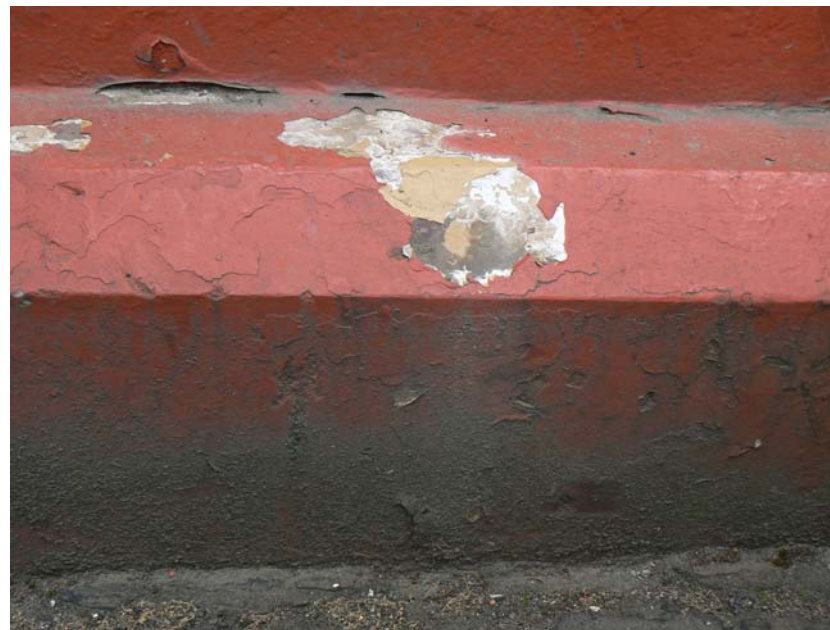
Description: Location of sample 09354106. The under coating are white and beige in color. The concert is exposed under the white paint.

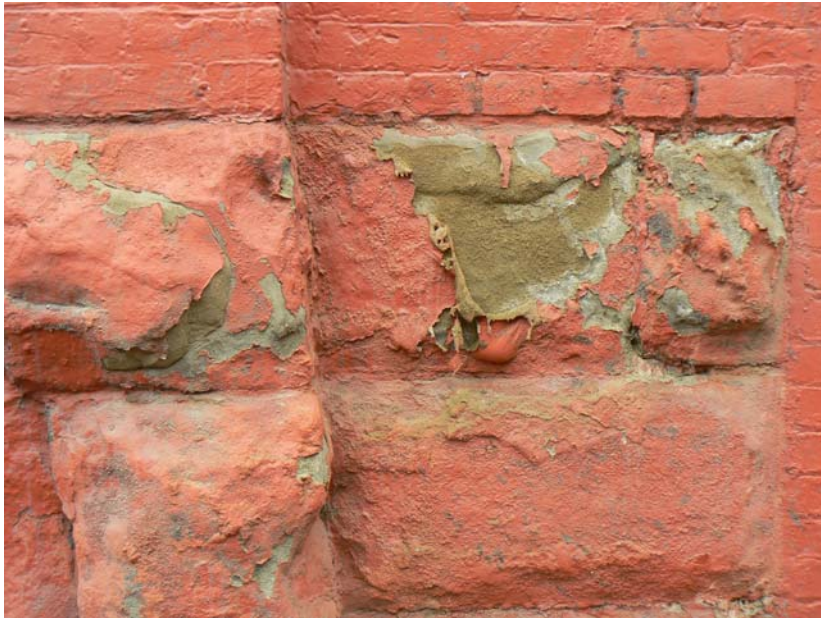
Photo No: P101143

Description: Location of sample 09354107. The rock used to build the wall near the stairs is exposed and breaks up easily when touched.

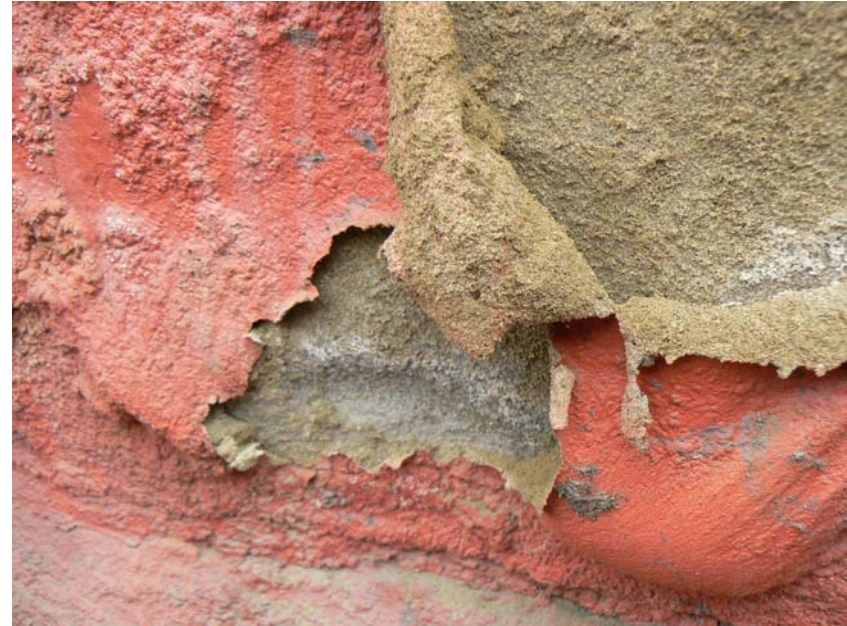
Description: Location of sample 09354107. The rock used to build the wall near the stairs is exposed and breaks up easily when touched.

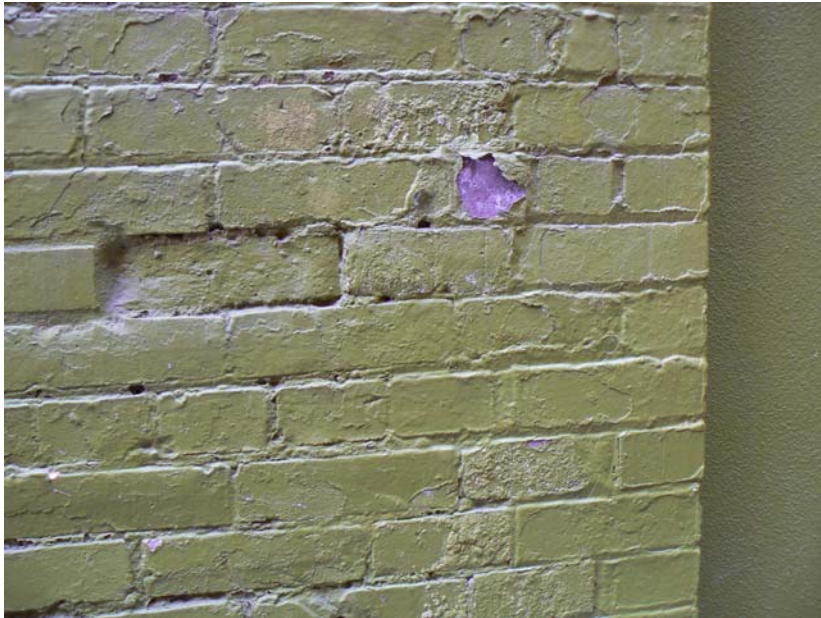
Photo No: P101145

Description: Location of sample 09354108. This is the west wall of Building 6, just north of the entry door (See 101146).

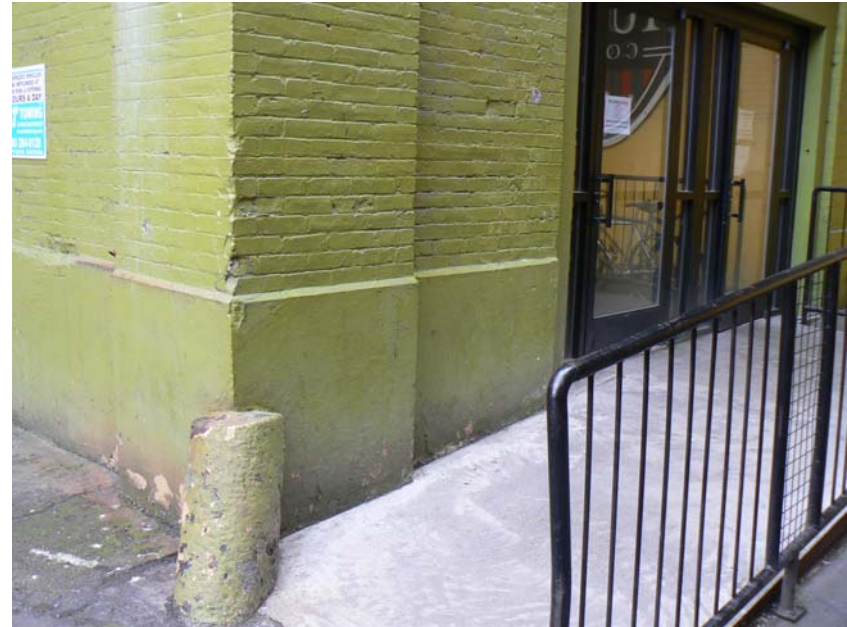
Description: Paint chips on the walkway leading to the door were combined with the flake paint sample taken from the location see in Photograph 101145.

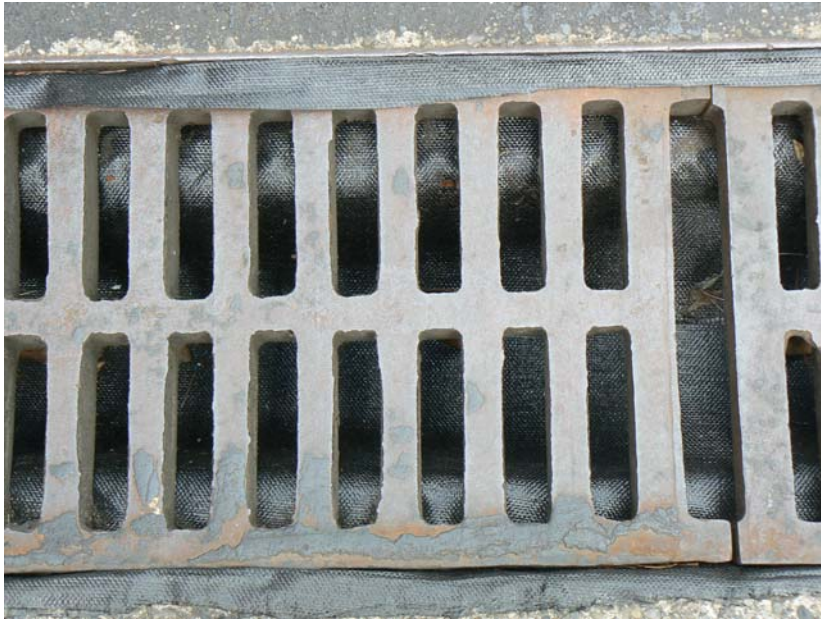
Photo No: P101147

Description: The catch basins in the ally behind Building 13 did not have a sufficient amount of debris for collecting. This is the same catch basin EPA sampled in March 2009.

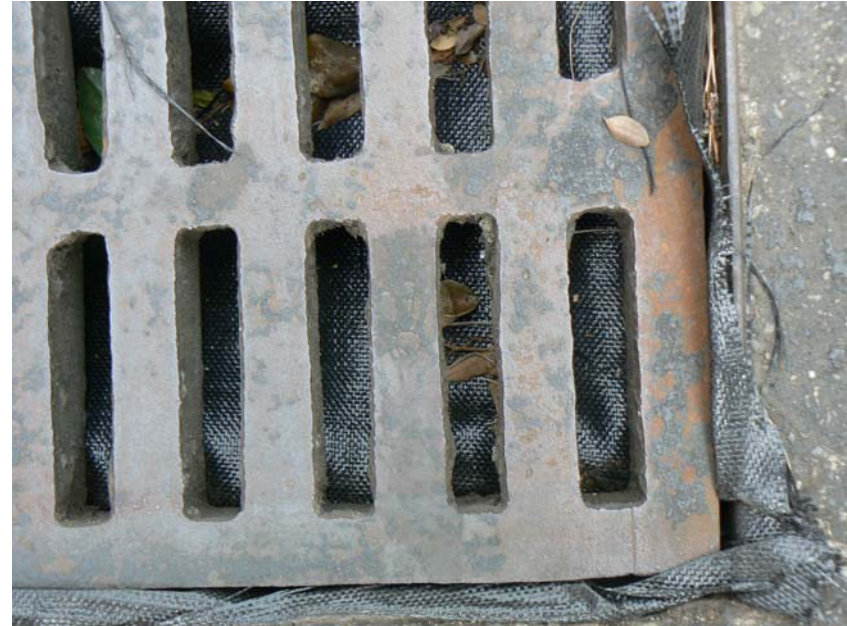
Description: Close-up of the new sock inside the catch basin.

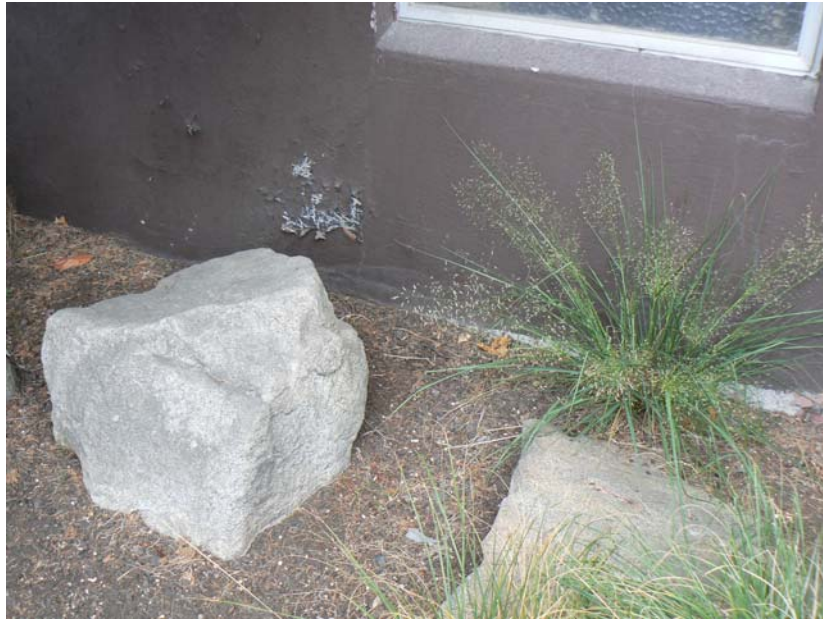
Photo No: P101150

Description: The coats of paint are brown over black and tan or beige. This is the location of sample 09354109.

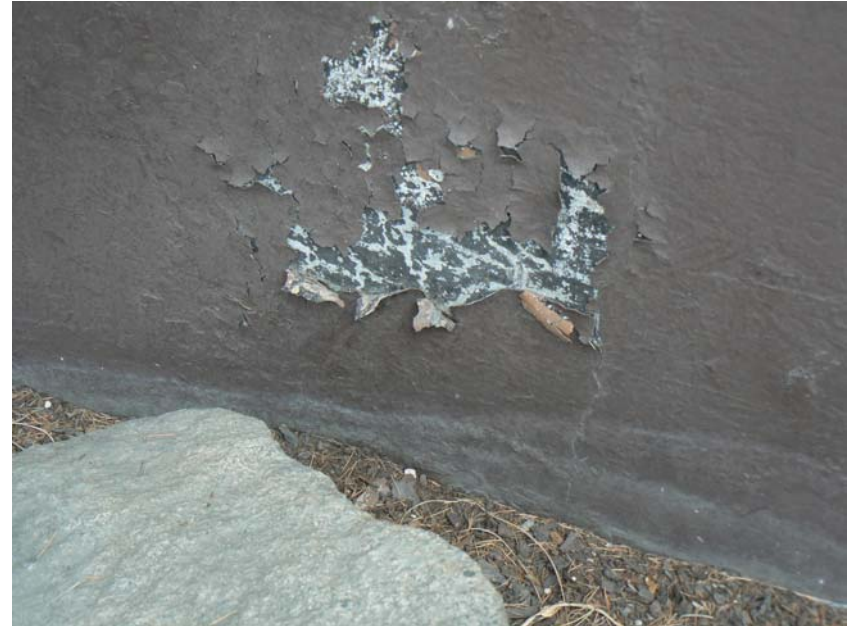
Description: The coats of paint are brown over black and tan or beige.

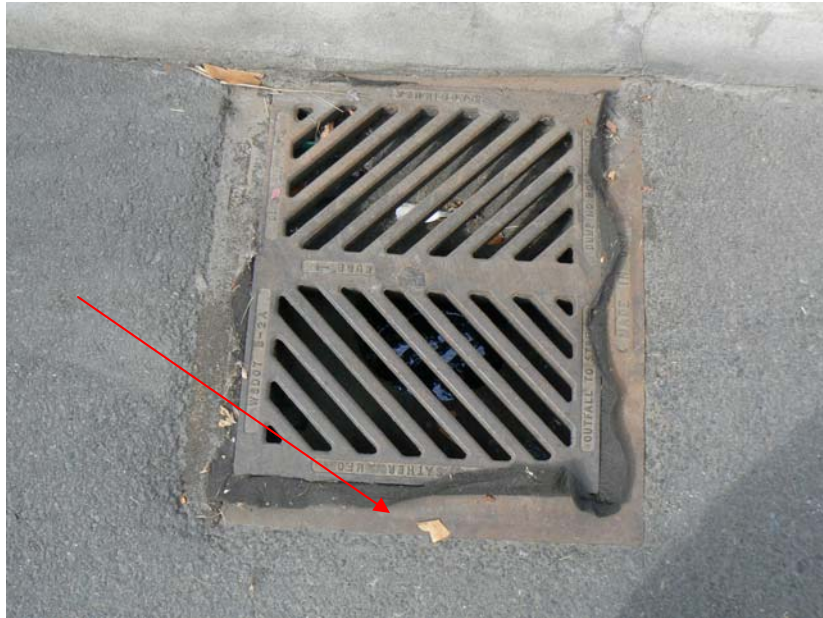
Photo No: P101152

Description: Paint chips on the edge of catch basin on the east road behind building 1. The paint is a tan or darker beige. The color of the paint chip is similar to the beige seen on Buildings 1 and 3.

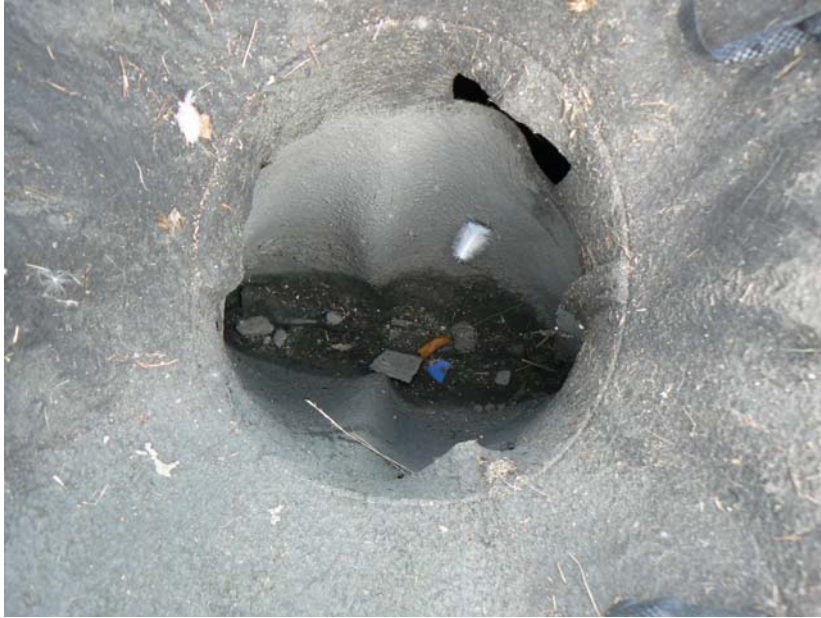
Photo No: P101156

Description: Catch basin east of Building 4. There is a little debris in the sock, but no paint chips are seen. The catch basin is up-hill from the Rainier Commons Building 4.

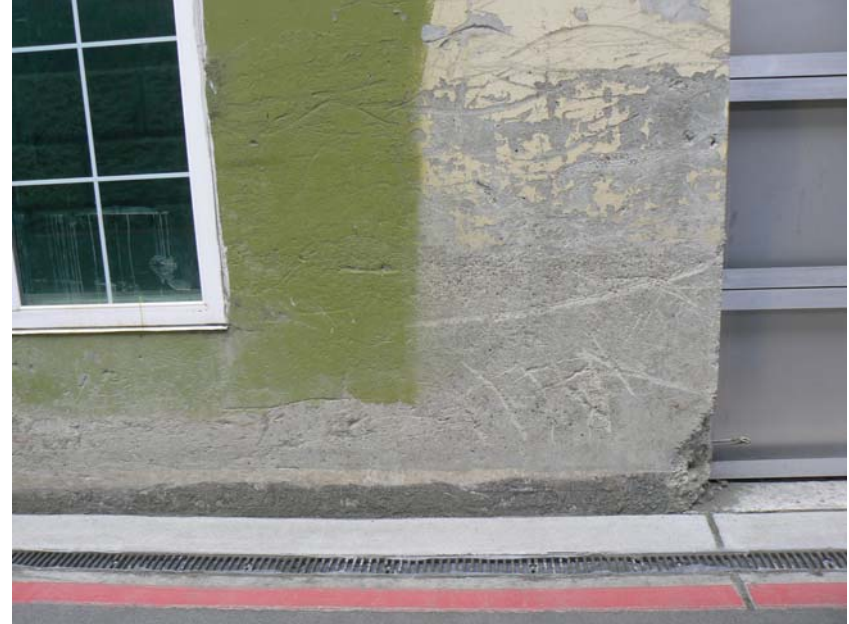
Description: Location of sample 09354110. This sample of paint was not covered by paint that had been applied after Rainier Commons, LLC purchased the property. The paint sample is two colors of beige.

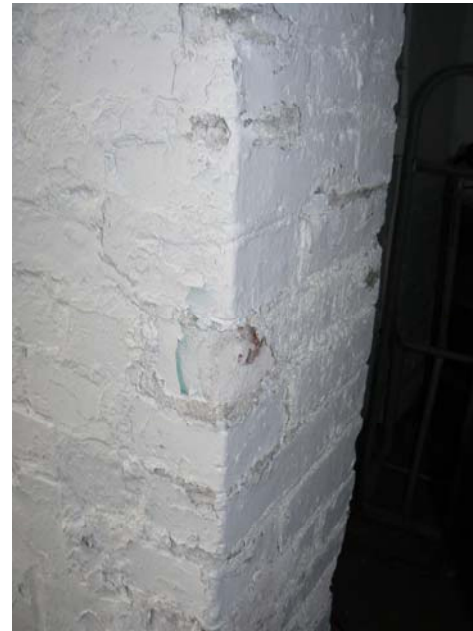
Description: Location of sample 09354111. The paint is white and the under coats are also white.

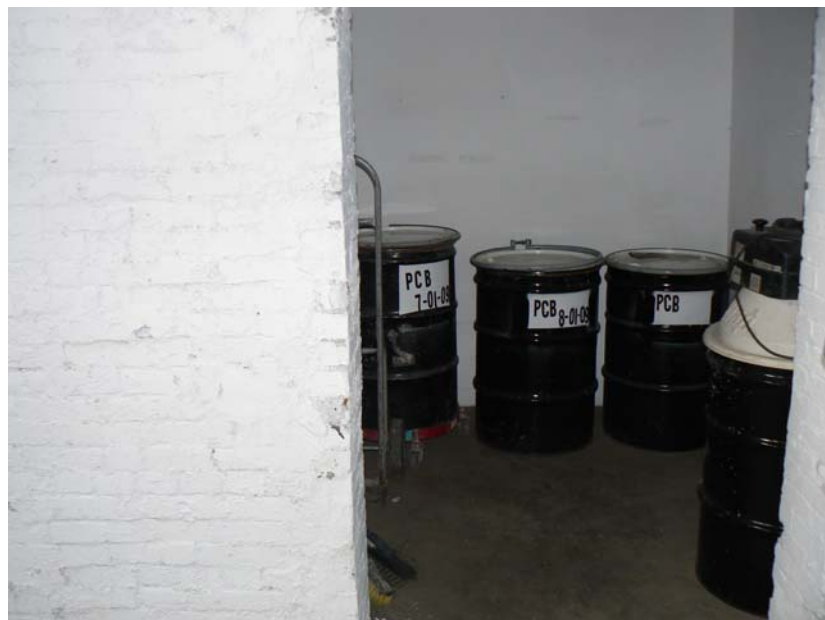
Photo No: P101160

Description: A little cove on the north wall of Building 12. All of the containers with debris picked up around the Old Brewery is marked with a date.

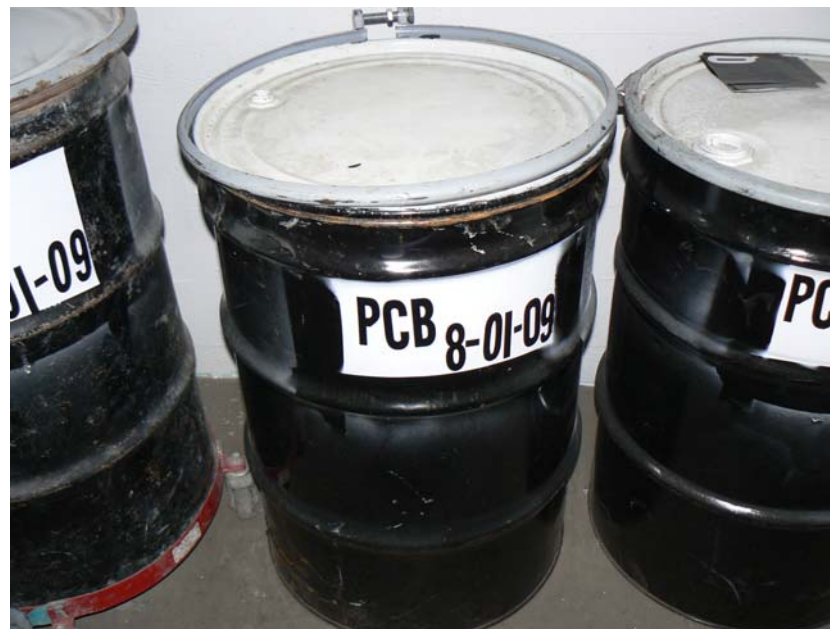
Description: The date on the containers is the starting date employees used to store contaminated debris that contains paint chips cleaned up around the Old Brewery.

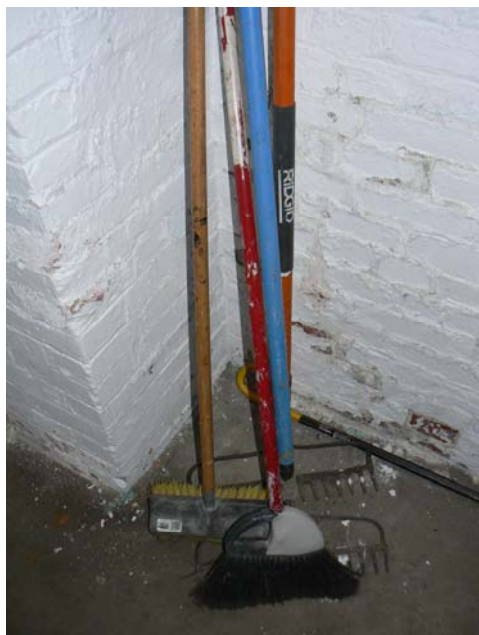
Photo No: P101162

Description: Brooms and rakes used to clean up paint chips at the Rainier Commons.

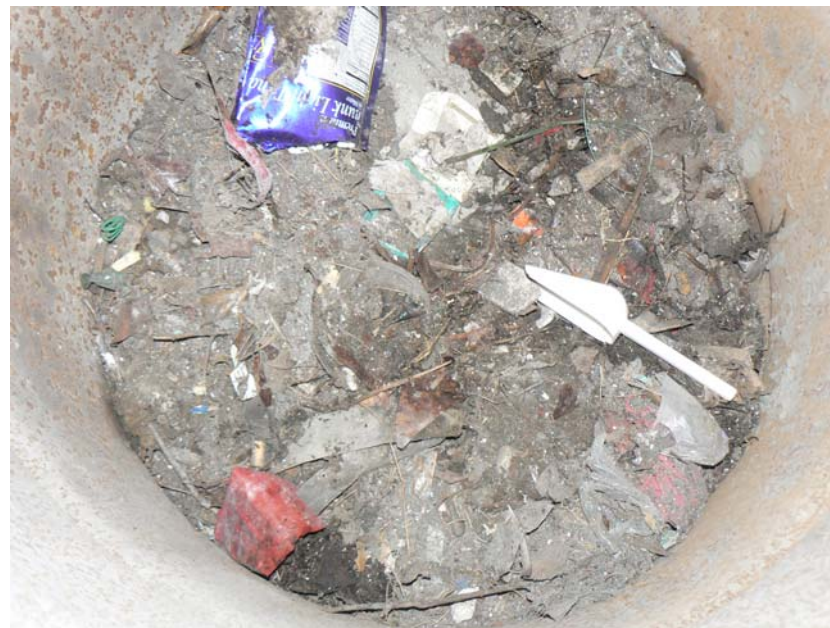
Description: Material inside the drum with the out of service date of 07/1/09. This is also the location of sample 09354112.
